Lane Departure Road Safety Audit for Thatcher Street in Brockton and East Bridgewater, Massachusetts

Prepared by
Old Colony Planning Council
and
University of Massachusetts Traffic Safety Research Program

May 2008

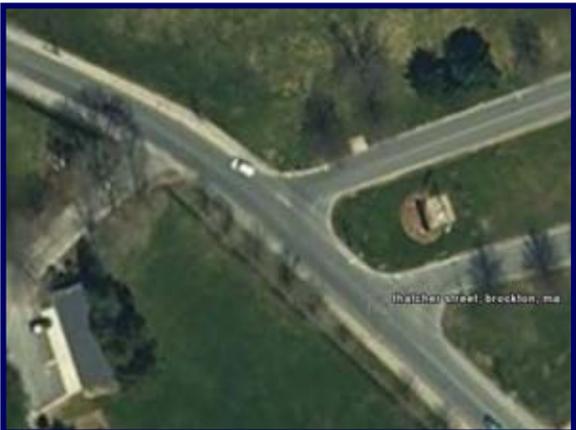
Figure 5 Horizontal Curve at Entrance to Massasoit Community College

- The entrance to Massasoit Community College was immediately cited as a potential safety concern. Specifically noted was that the intersection, which is actually two smaller intersections because of the two access drives (see Figure 5), is on a horizontal curve that inhibits sight distance. The concern was enhanced given the traffic volumes, and in particular, the younger driver volumes, at this location.
- The horizontal curve at the southern portion of Thatcher Street was also cited as a safety concern. RSA team members noted the limited amount of delineation and close proximity of roadside hazards through this curve.

- Install “Curve Ahead” warning signs and chevrons for each direction ahead of the two horizontal curves described previously. Signs should be placed in advance of the curve to allow adequate response time for motorists. To further enhance the delineation, roadside reflectors and/or chevrons should be considered as budget permits.

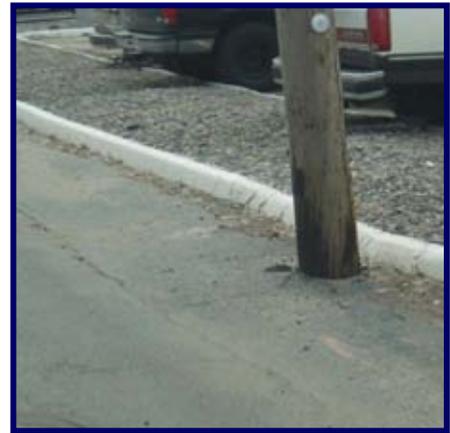
Figure 6 Hazardous Utility Pole

- Roadside hazards in general were mentioned as a safety concern along the roadside. For a significant portion of Thatcher Street, utility poles and trees are frequently observed within 4 to 5 feet of the travelled way. An example of this is the utility pole near the town line that is actually located within the curb line as shown in Figure 6. Similarly, there is a significant amount of roadside vegetation in close proximity the roadway, specifically in the areas south of Massasoit Community College.

Presence of utility poles within the roadway clear zone	Reflectorize utility poles.	Short Term & Low Cost	Low	Brockton, East Bridgewater, OCPC & Utilities

Work with utility company to remove utility poles from clear zone.	Long Term & Mid/High Cost	Mid		
Minimize edge drop-off and maintain roadside	Maintain and fill roadside as needed to prevent edge drop-off. Clear debris and vegetation in close proximity to the roadside.	Short Term & Low Cost	Low	Brockton & East Bridgewater

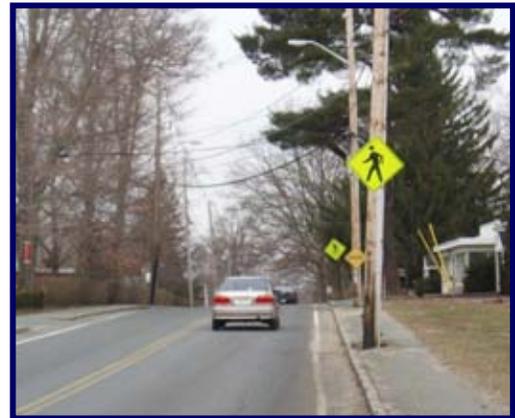
Figure 7 Sight Limited Crosswalk

- Although there is appropriate signage alerting motorists of the presence of crosswalks just north of the college entrance, the limited sight distance provided by the vertical curve is a concern (see Figure 7). Some consideration may be given to the removal or relocation of this particular crosswalk based upon a study of pedestrian usage. If the crosswalk is considered vital, future thought may be given to added pedestrian conspicuity or speed control (e.g. bulb outs).

Evaluate safe crossing opportunities for pedestrians	Determine if existing crosswalks are needed or recommended. If yes, identify opportunities to improve visibility, including possible relocation.	Short Term & Low Cost	Low/Mid	City of Brockton & Massasoit Community College

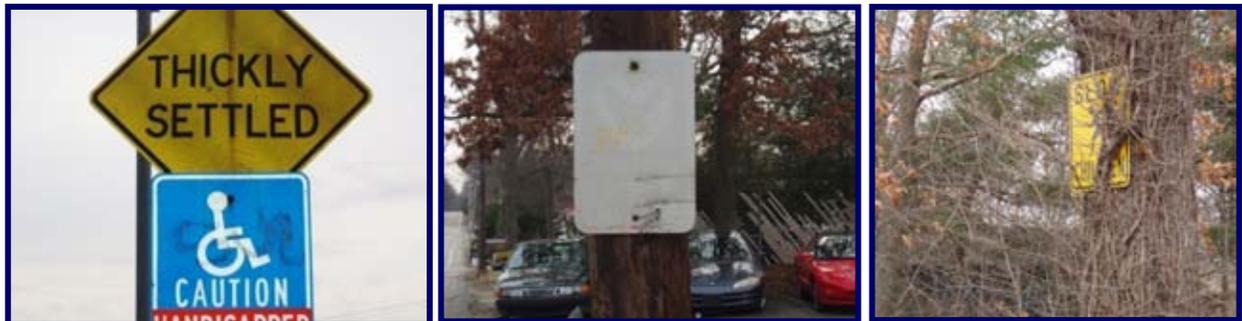
Figure 8 Example of Sign Conditions

- The condition for a majority of signage along Thatcher Street is to some extent faded, not highly retroreflective, vandalized, or obstructed by vegetation. All signs on both sides of the city/town line should be inspected and replaced as necessary. Some examples are pictured in Figure 8.

Improve existing signage	Throughout the corridor there are numerous signs that are not highly retroreflective (retroreflective signs must meet new MUTCD standards). These signs are faded, vandalized, or obstructed and should be replaced.	Short Term & Low Cost	Low/Mid	Brockton & East Bridgewater

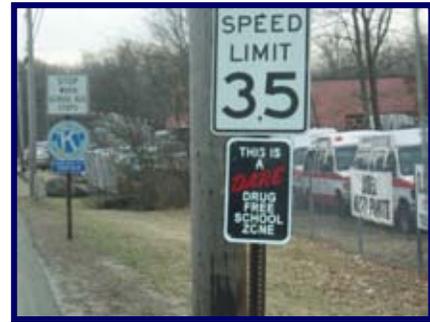
Figure 9 Inappropriate Speed Limit Sign

- Another major concern was overall speeds along the corridor, which was reported anecdotally by RSA team members and verified with observed data from the OCPC study. Near the town line, which is a relatively straight and level section, the 85th percentile speed was 45 mph. This value is approximately 15 mph above the prima facie limit for this segment. Related to this were reports of several RSA team members that cited frequent tailgating throughout this corridor, and passing of vehicles even though passing is prohibited. As previously noted, there are currently speed limit signs in East Bridgewater posted at 35 mph; however, these are not official regulations and should be removed.

- As noted, there are no current approved speed regulations for Thatcher Street. Currently, existing signage with a posted 35 mph speed limit are located in the East Bridgewater portion of the roadway (see Figure 9). These signs should be removed. The current speed limit is governed by the prima facie limit of 30 mph for a thickly settled area. Moving forward, a recommendation may be to have the segment studied and petition for a speed zone.

Remove all unauthorized white and black speed limit signs, which are not official regulations. May consider developing established speed zones.	Short Term & Low Cost	Low

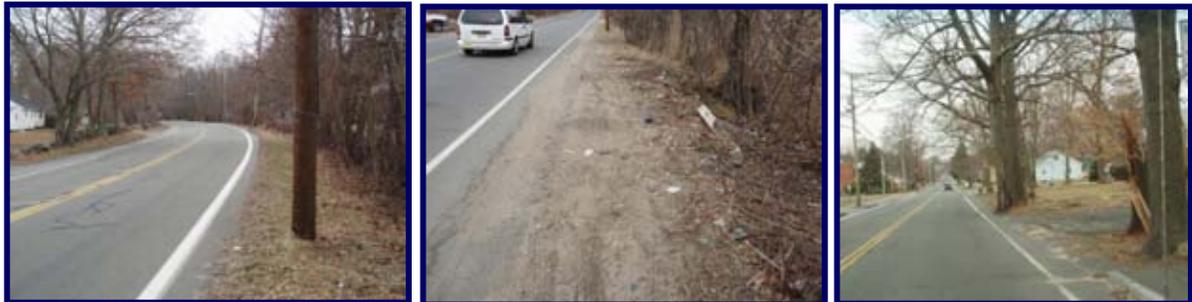
Figure 10 Example of Potentially Hazardous Roadside Elements

- The condition of the roadside was noted as a concern. There are several specific aspects that warrant further consideration, including, but not necessarily limited to edge drop-off, utility poles, trees, and vegetation in general as shown in Figure 10. With respect to the utility poles, some currently have reflectors while others do not. It is recommended that longer range plans for the removal or relocation of hazardous utility poles be developed; however, in the interim it is recommended that improved reflectorization be added to the poles, specifically in the southern, darker stretches where there is no curbing. Overall it is recommended that the roadside be improved to minimize the aspects of edge drop off, thus improving the likelihood of a vehicle being able to maintain control at the roadside. However, it is recognized that this is particularly tied to improved drainage as discussed previously. Lastly, it is recommended that hazardous trees be removed and that vegetation be maintained.

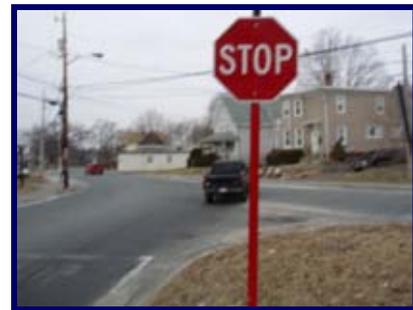
Figure 11 Existing Pine Street Stop Control

- The intersection with Pine Street at the northern end of Thatcher Street is a safety concern. Specifically, the intersection is skewed, and at this intersection Thatcher Street traffic is required to stop. Although enhancements have been made to the current stop control (see Figure 11), more conspicuity is recommended. Possible countermeasure considerations include advance warning signage, advance “STOP AHEAD” pavement markings, or a flashing beacon (either stop sign mounted or overhead).
