# Lane Departure Road Safety Audit for Route 24 through Old Colony Planning Council

Prepared by  
Old Colony Planning Council  
and  
University of Massachusetts Traffic Safety Research Program

Massachusetts Highway Department

May 2008

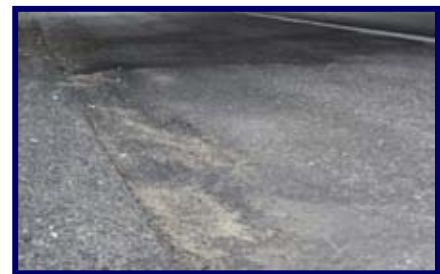
- Drainage was reported to be inadequate throughout the corridor. Specifically cited were areas in Avon and Stoughton that regularly flood during weather events. RSA team members mentioned that in the northbound direction, there was frequent rutting throughout. A related issue that was raised was pavement and drainage under a majority of the overpasses where the top layer of pavement is deteriorated (see Figure 3).

**Figure 3 Drainage and Pavement Concern at Overpasses**

- Evaluate existing drainage facilities. Although some long-term strategies are likely needed, cleaning existing catch basins may reduce some of the ponding that currently exists along Route 24.

Repair pavement and drainage areas beneath overpasses.	Mid Term & Mid/High Cost	Low/Mid	
	Perform catch basin inspection to improve current drainage.	Short Term & Low Cost	Low/Mid	
Disabled/parked vehicles	Reaffirm existing policy regarding treatments for disabled/parked vehicles including the use of CaresVan and Massachusetts State Police.	Short Term & Low Cost	Low

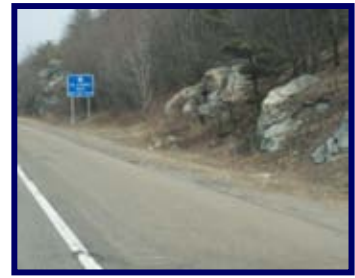
- Some of the existing signage is partially obscured by vegetation. Although this was observed at several locations throughout, it appeared to be most noticeable in the northbound direction through Avon.
- Along the roadside in the northbound direction in Avon, there is a section of ledge in close proximity to the roadway (see Figure 4).
- The existing pavement markings are considerably faded and should be improved to enhance delineation. There are rumble strips along the left and right shoulders along a majority of Route 24 that appear to be in good condition.

**Figure 4 Section of Ledge**

Presence of trees and ledge along roadside	Consider guardrail installation near Avon ledge adjacent to roadside.	Mid Term & Mid Cost	Low
