ROAD SAFETY AUDIT

Washington Street (Route 138) at Central Street
Town of Stoughton

March 2016

Prepared By:
McMahon Associates, Inc.
45 Bromfield Street, 6th Floor
Boston, MA 02108

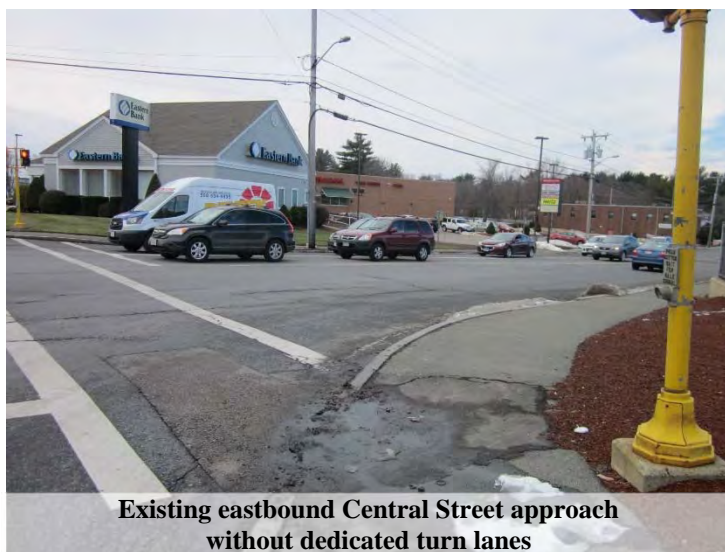
There were multiple traffic control issues for the intersection of Washington Street (Route 138) and Central Street discussed during the RSA. Audit participants noted that the shared left-turn/through lanes in both the eastbound and westbound direction on Central Street often operate as de facto left turn lanes. It was discussed that through traffic often gets trapped behind vehicles waiting to make a permissive left turn, particularly in the westbound direction where there is a lag-left protected phase. Participants stated that the de facto left turn lanes often lead to elevated driver frustration, which might cause drivers to suddenly switch lanes or travel through the red light, thus increasing the potential for crashes. The audit team stated that there are no pavement markings or signage along either Central Street approach indicating lane designations and they also noted that the left turn only lane utilization sign was missing from the mast arm for the northbound approach on Washington Street.

- Restripe roadway to provide exclusive left turn lanes for both the eastbound and westbound Central Street approaches.
- Add pavement markings and “Left Lane Must Turn Left” signage to alert drivers of the lane designations along Central Street.

- Add lane utilization signage to both Central Street approaches to give drivers advanced warning of the turn lane restrictions.
- Replace missing lane utilization sign on the northbound Washington Street approach to alert drivers to the turn lane configuration.

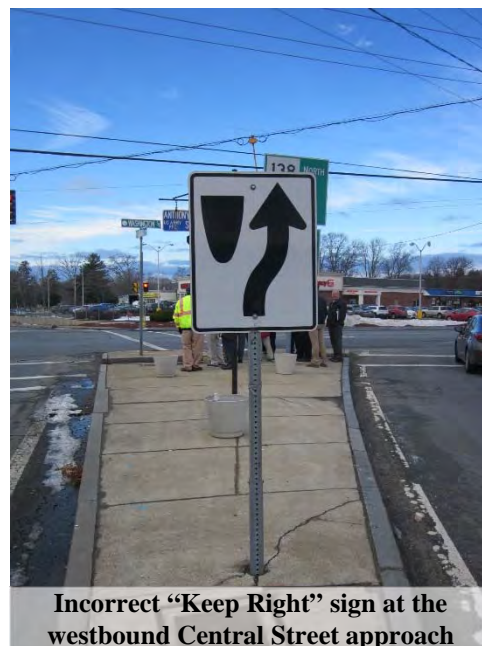
While on the site visit, there were a few issues observed with the existing traffic control devices. It was noted that some of the back plates for the signal heads were damaged, which may impact the visibility of the signals. A participant also stated that the number of signal heads and their placement could also be contributing to driver confusion at the intersection. Another issue noted was that the “Keep Right” sign located within the westbound island does not meet current MUTCD standards. The audit team also discussed that some of the existing pavement markings were faded.

- Evaluate a coordinated signal system along Central Street including its intersection with Pearl Street, Washington Street, and Pleasant Street.
- Replace missing or damaged back plates with reflectorized back plates.

- Evaluate current signal head placement and quantity to minimize driver confusion.
- Update “Keep Right” sign located within the island of the westbound intersection approach to meet current MUTCD standards.
- Restripe faded pavement markings.

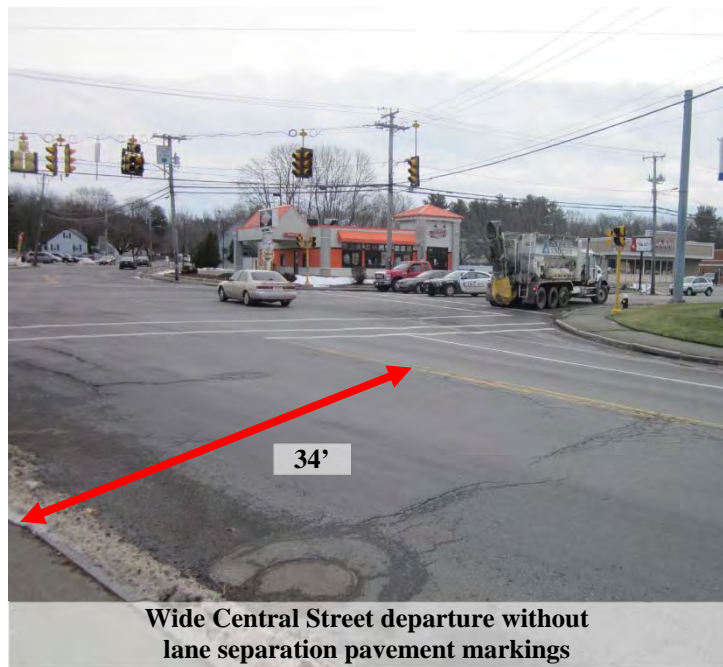
Audit participants also noted that the widths of the departing lanes on Central Street are very large and unmarked. Both the eastbound and the westbound departure lanes are measured to be approximately 34 feet at the intersection of Washington Street (Route 138) and Central Street, without any pavement markings clearly separating the two departing lanes in each direction. It was discussed that this lack of markings can cause confusion between drivers turning right on red from Washington Street (Route 138) onto Central Street and those traveling straight on Central Street. The transitions and tapers along both Central Street approaches and along Washington Street to the south of the intersection were discussed as areas that could contribute to driver confusion and, as a result, potential crashes.

- Align opposing exclusive left turn lanes on Central Street directly opposite each other to enhance visibility and improve sight lines across the intersection.
- Evaluate restriping and/or narrowing of departing lanes on Central Street in conjunction with the exclusive left-turn lanes and single through lanes.
- Widen Central Street to allow one exclusive left turn lane and two through lanes in both the eastbound and westbound direction to reduce delay and queuing as a long term enhancement.
- Evaluate transitions and tapers along the corridor.

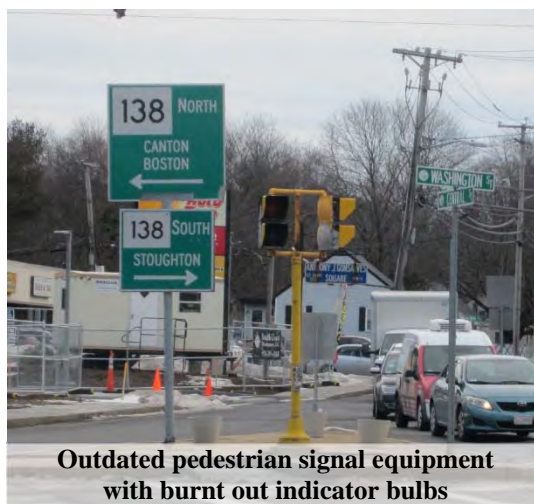
RSA participants noted that the current pedestrian signals and push buttons at the intersection are outdated and do not meet current standards. The pedestrian signal heads were also not consistent within the intersection, some with word indications for walk and don't walk and some with symbol indications. It was also noted that some of the lights on the pedestrian signal heads were burnt out.

- Update outdated pedestrian signals and include pedestrian signal heads with countdown timers.
- Update outdated push buttons so that they are compliant with MassDOT standards.

- Replace burnt out bulbs on existing pedestrian signal heads.
- Evaluate the existing pedestrian phase to ensure sufficient crossing time for pedestrians.

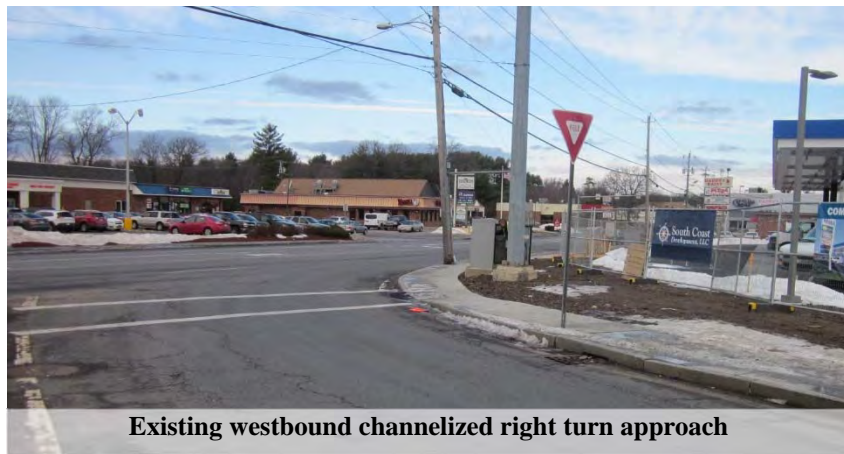
The westbound channelized right turn was identified as another area where conflicts between pedestrians and vehicles could potentially occur. Vehicles that are turning north from the westbound approach might be looking to see if there are any oncoming vehicles rather than focusing on pedestrians that might be crossing the approach. The channelized right turn is not currently signalized for either the motorists or the

pedestrians. A participant noted that there are no advanced yield pavement markings or signs to indicate that a vehicle should be prepared to stop. In addition to the lack of yield markings, the RSA team noted that the current crosswalk striping was not visible to drivers at the westbound right approach or along any of the other intersection approaches.

Existing westbound channelized right turn approach

- Install warning signage and pavement markings to the channelized westbound right turn to alert drivers to a potential pedestrian crossing.
- Consider adding a vehicle signal and a pedestrian signal for the westbound channelized right turn lane.

- Relocate the crosswalk across the channelized right turn approach so that one vehicle can queue in front of the crosswalk while waiting to merge onto Washington Street.

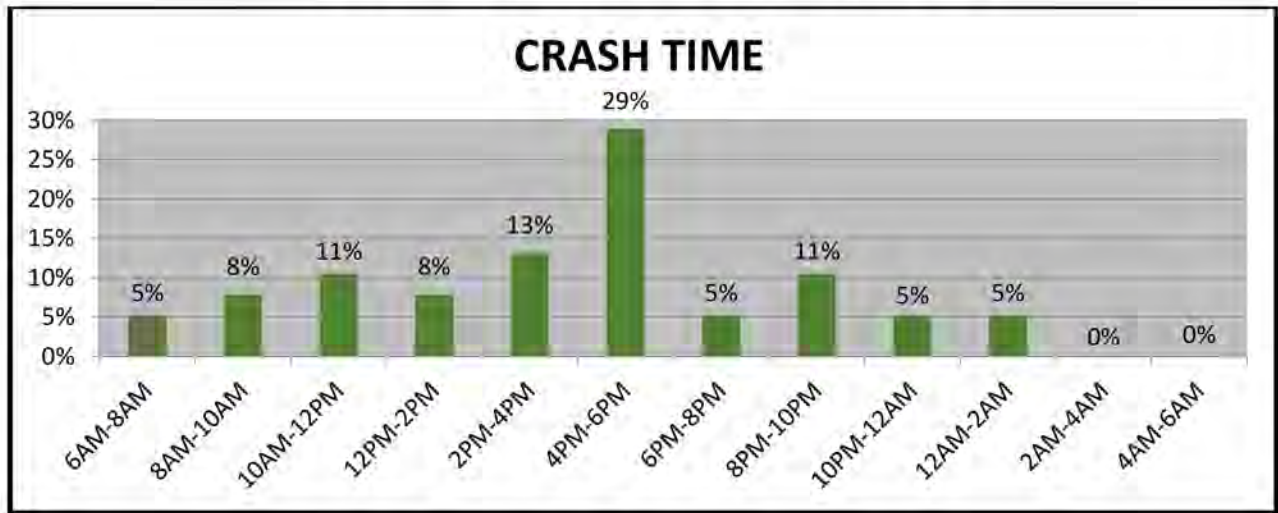
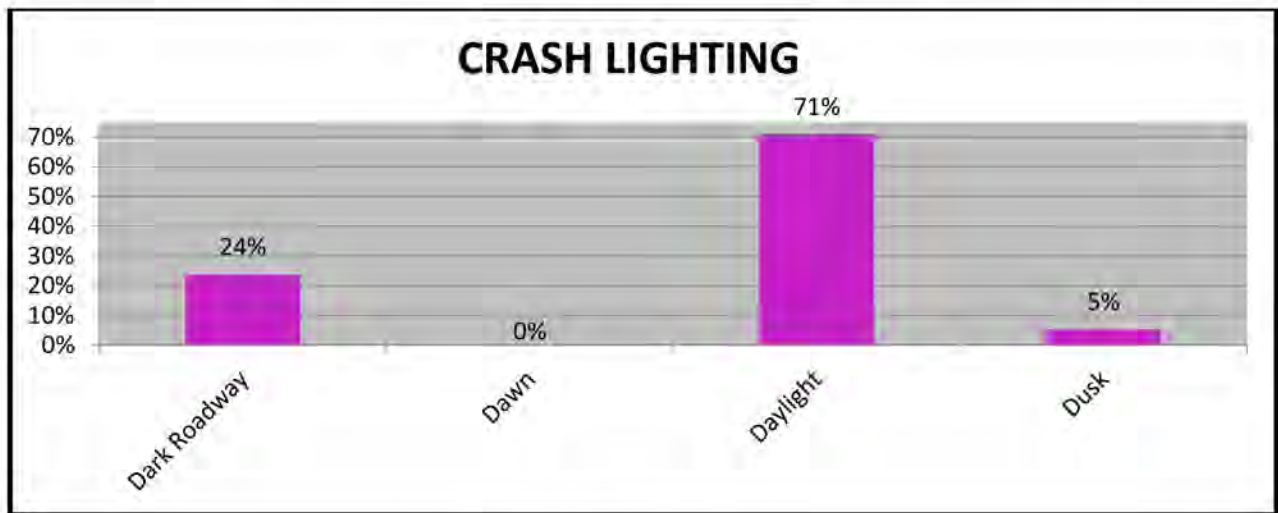
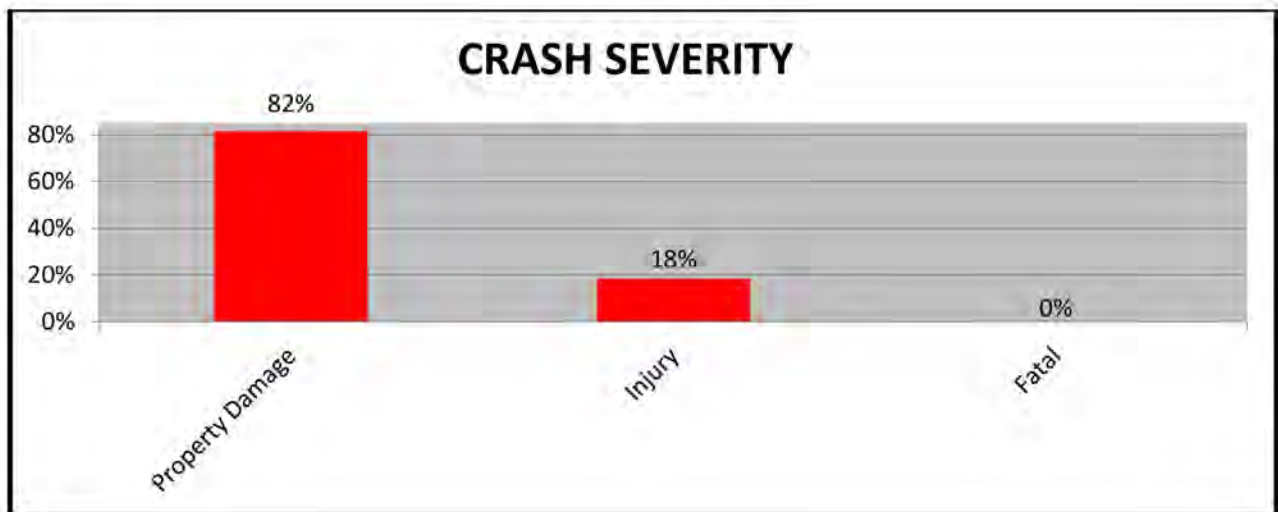
Crash Data Summary Charts
Rte 138/Washington St at Central St, Stoughton, MA

Crash data was obtained from the Town of Stoughton for the most recent three-year period available. The data includes yearly crash summaries for the three-year period from 2012 to 2014. Based on this data, there were a total of 38 crashes reported from the beginning of 2012 through the end of 2014 at the intersection of Washington Street (Route 138) and Central Street. The crash rate based on the local crash data for the intersection of Washington Street (Route 138) and Central Street is shown to be 1.00 crashes per million entering vehicles. Of the crashes that occurred at the intersection of Washington Street (Route 138) and Central Street, 20 (53%) were angle collisions. The angle crashes that occurred at the intersection may be caused by insufficient clearance intervals for through and left turning vehicles. Additionally, there were 12 (32%) rear-end collisions distributed relatively evenly among each of the intersection approaches. There were also three sideswipe crashes, two head-on collisions, and one single vehicle crash. Of the reported 38 crashes, seven (18%) resulted in personal injury and there were no fatalities reported at the intersection. March was the month with the highest number of crashes, equaling 18% of the total collisions, and 34% of the total crashes occurred on a Monday. The data also indicated that 71% of the crashes occurred during daylight conditions, with 29% of crashes occurring between 4:00 PM and 6:00 PM.
