Lane Departure Road Safety Audit for Thatcher Street in Brockton and East Bridgewater, Massachusetts

Prepared by
Old Colony Planning Council
and
University of Massachusetts Traffic Safety Research Program

May 2008

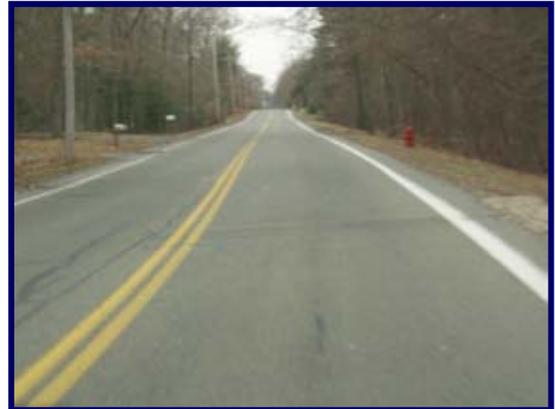
Figure 2. View of Thatcher Street

Thatcher Street is a 2.1 mile long collector roadway that connects Pine Street in Brockton, Massachusetts and Summer Street in East Bridgewater, Massachusetts. The City of Brockton and Town of East Bridgewater are located in Plymouth County in eastern Massachusetts with approximate populations of 95,000 and 14,000, respectively. Thatcher Street is one lane in each direction; however, there are observable differences in both land usage and roadway characteristics on either side of the town line, which cuts through Thatcher Street. For example, there are more adjoining side streets and adjacent residences along the Brockton section of the roadway. By comparison, the East Bridgewater segment of Thatcher Street has limited residences and/or businesses and no adjoining side streets. Some of the major landmarks along Thatcher Street include a landfill facility and Massasoit Community College, which is a major traffic generator. From a geometry perspective, there is one slight vertical curve (Brockton side) and 2 horizontal curves (one in each Brockton and East Bridgewater). Throughout, Thatcher Street has 12 foot lanes, and despite marked edgelines, there are limited shoulders. A typical view of Thatcher Street is shown in Figure 2, and some of the major characteristics are summarized in Figure 3.
